City Water, Light, and Power  
Coal Combustion Residual Units

35 IAC 845 Weekly Inspection Form

Date 9/28/22 Time 10:30

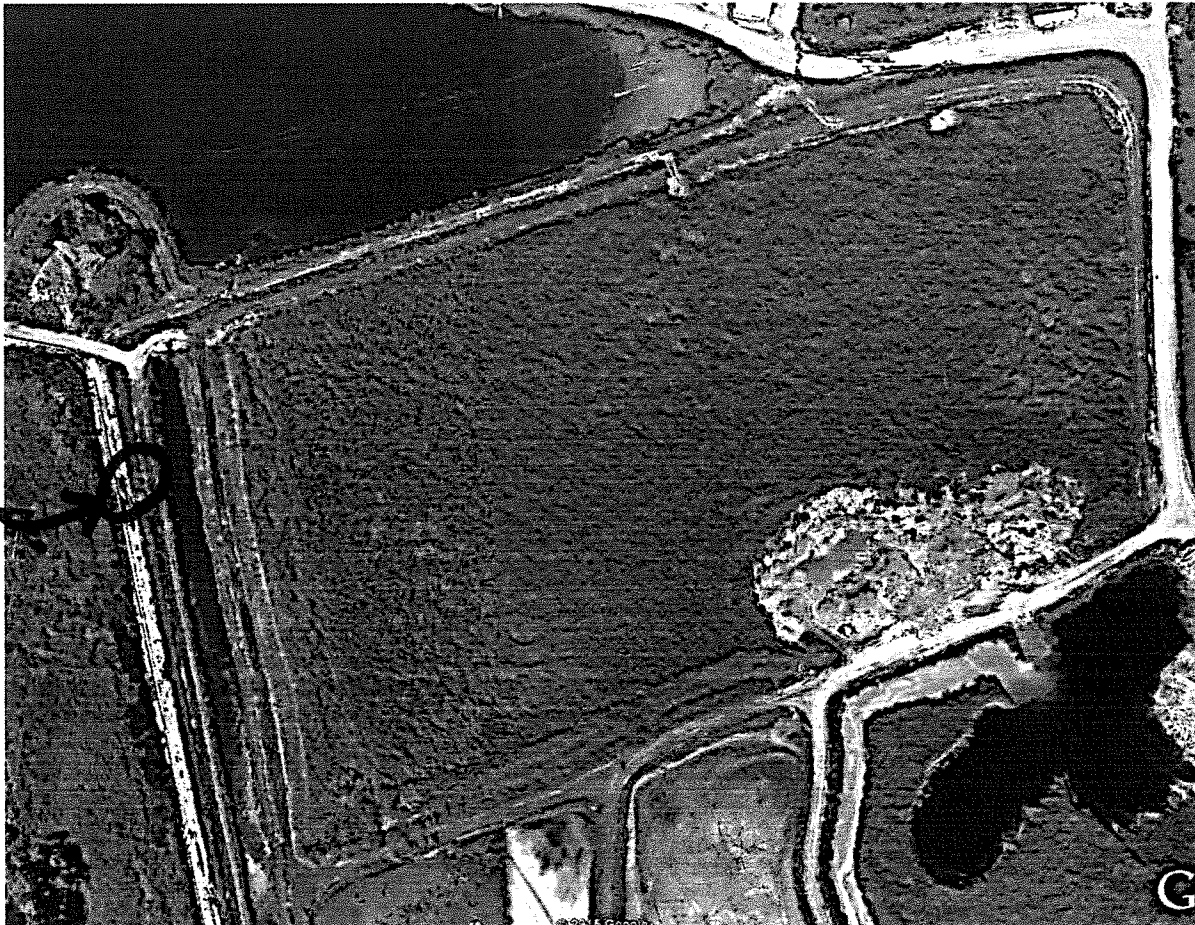
**Berms – Lakeside Ash Pond**

☒ Seeps / Damp Areas

*Ground damp at seep (likely)*

*likely  
seep*

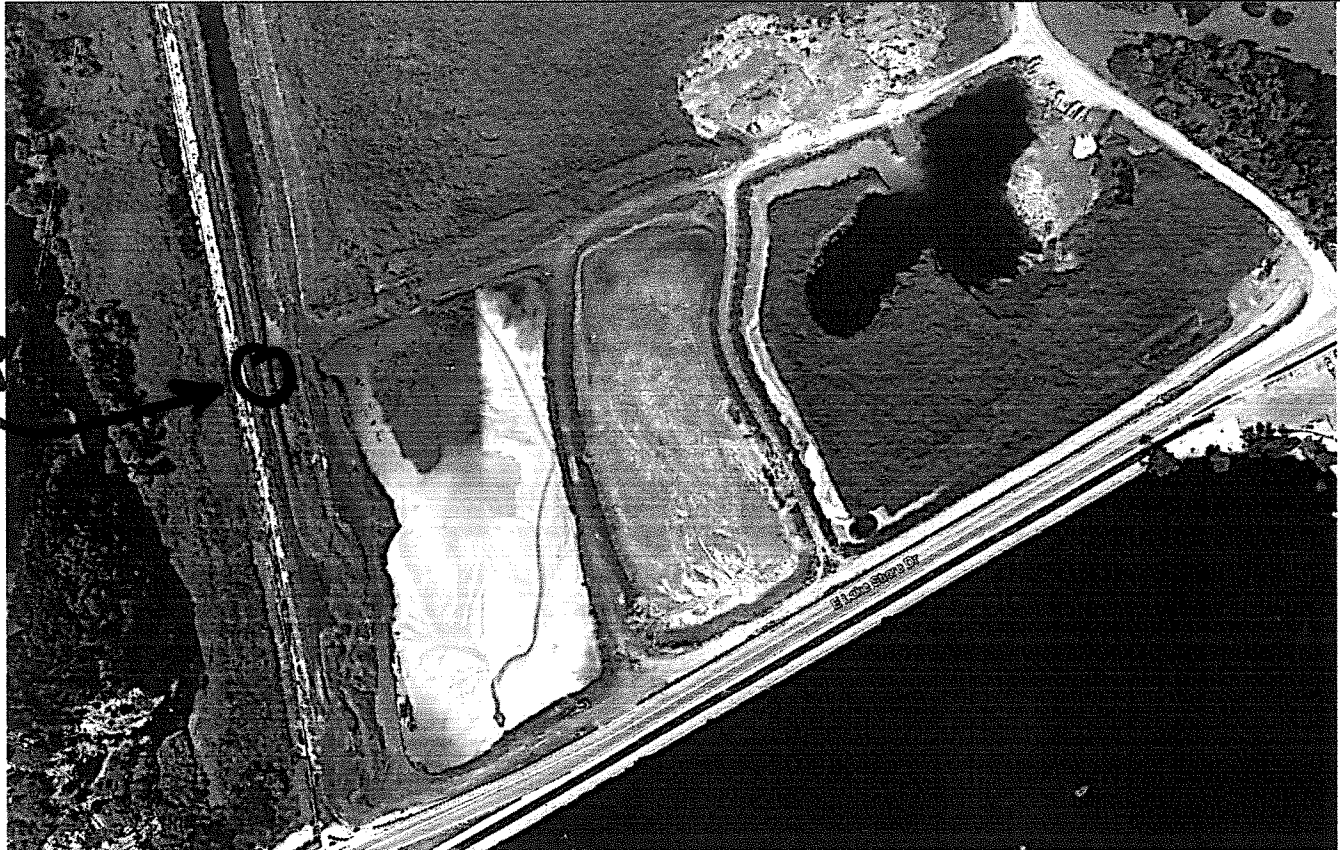
**Berms – Lime Softening Ponds**

☒ Seeps / Damp Areas
