City Water, Light, and Power  
Coal Combustion Residual Units

35 IAC 845 Weekly Inspection Form

Date 6-9-21 Time 10:30 AM

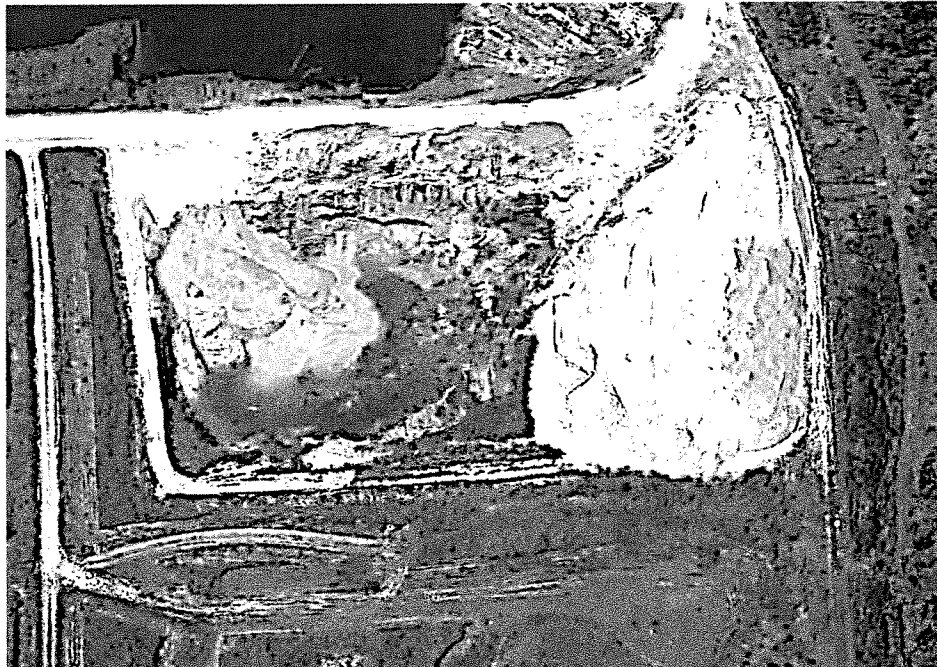
Berms – Landfill Unit 2:

☒ No observed problems

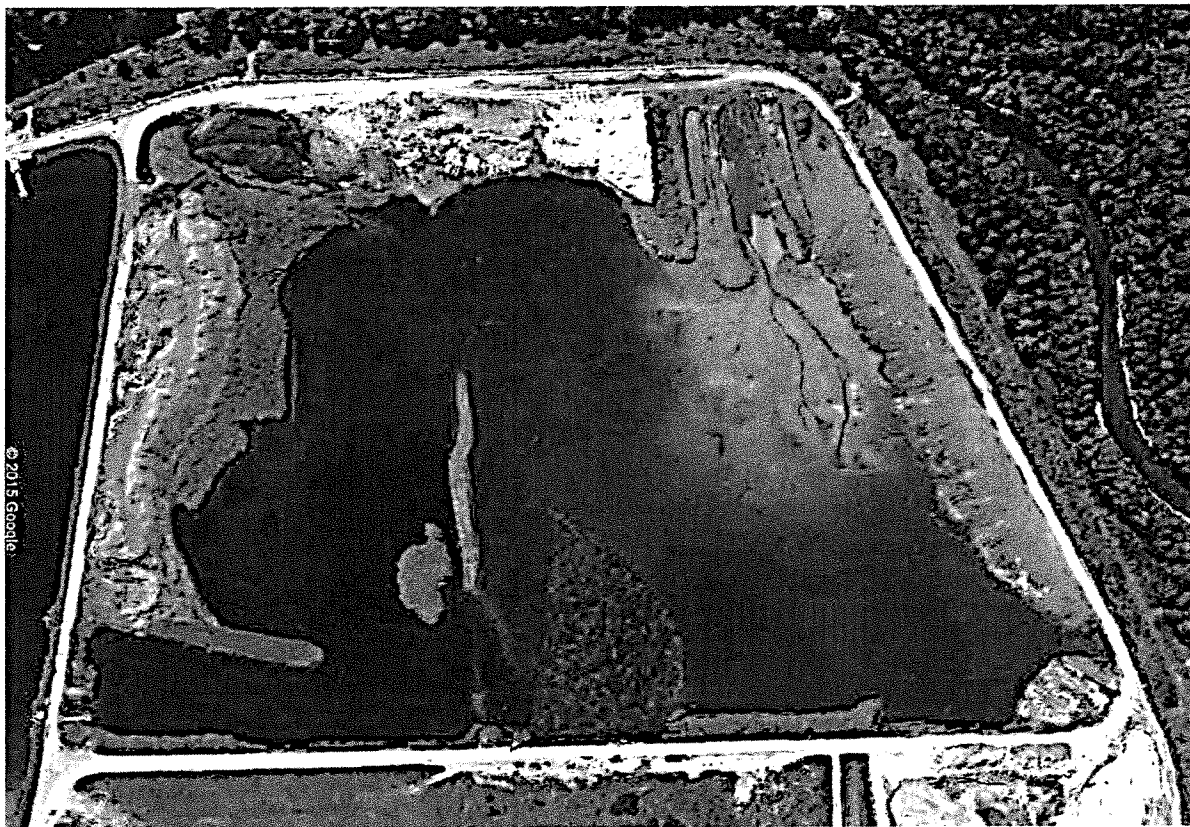
### Berms – Dallman Ash Pond

- ☐ Sudden drop in impoundment level  
☐ Actual or potential structural weakness  
☐ Improper operation of overtopping control  
☐ Visible release  
☒ No observed problems

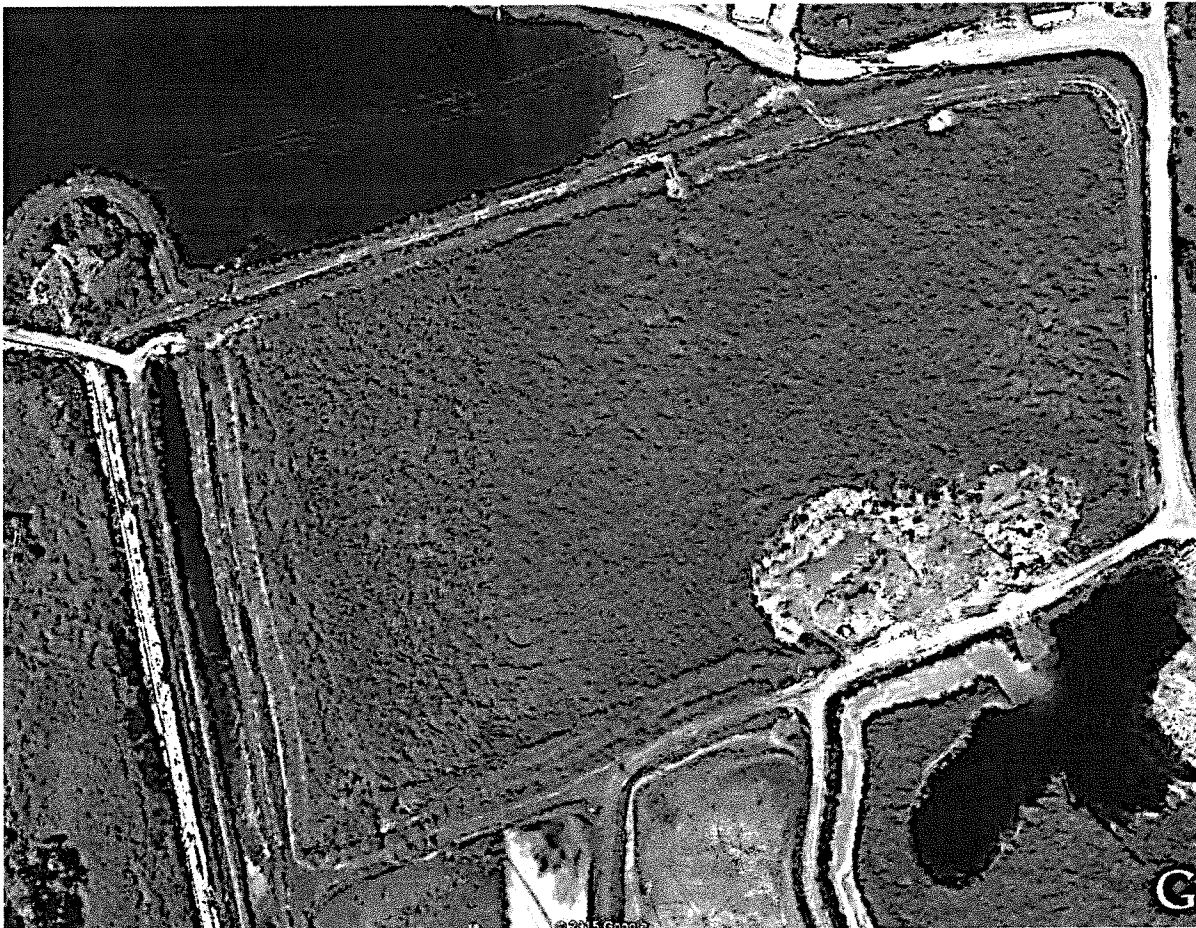
**Berms – Lakeside Ash Pond**

☒ No observed problems

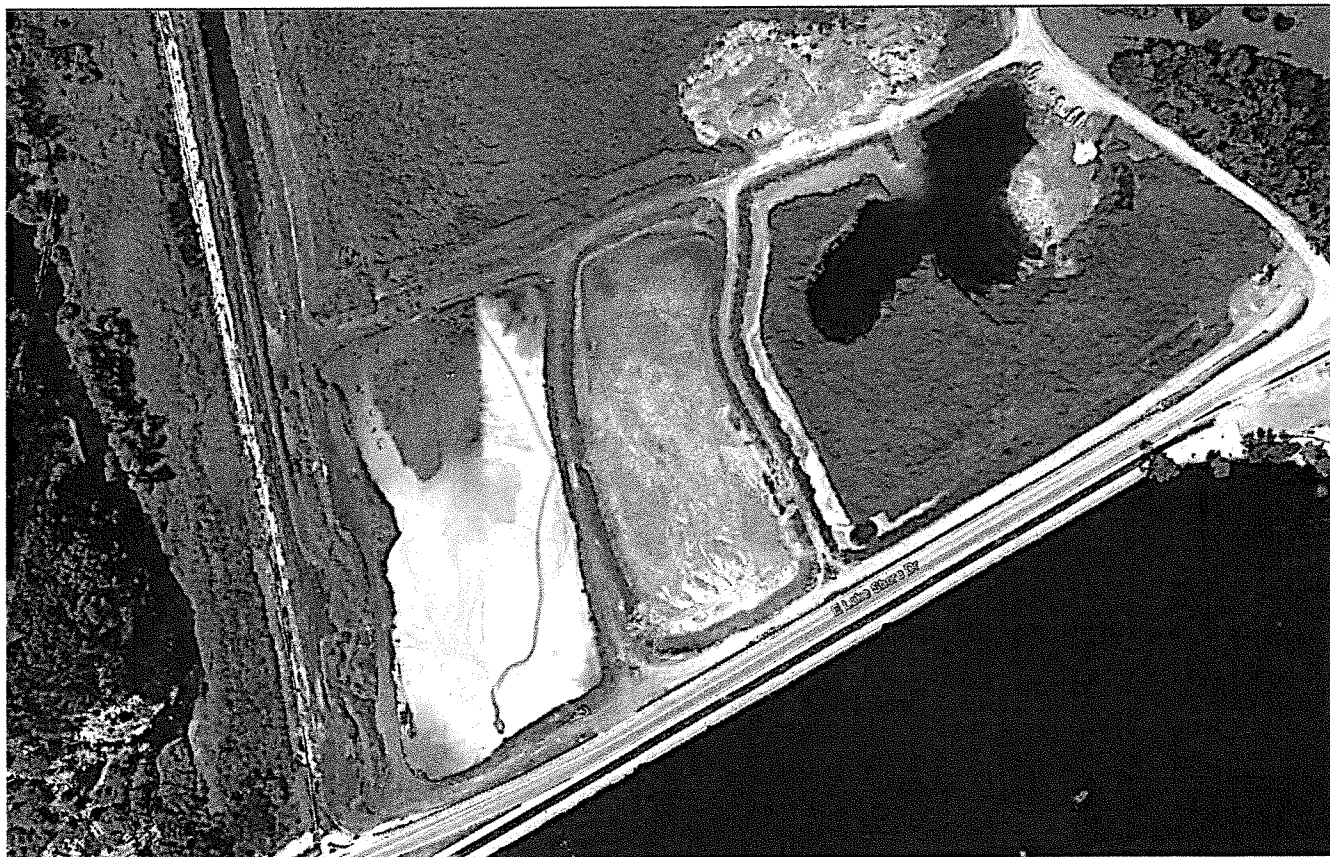
### Berms – Lime Softening Ponds

☒ No observed problems
