35 IAC 845 Weekly Inspection Form

Berms - Lakeside Ash Pond

Berms - Lime Softening Ponds

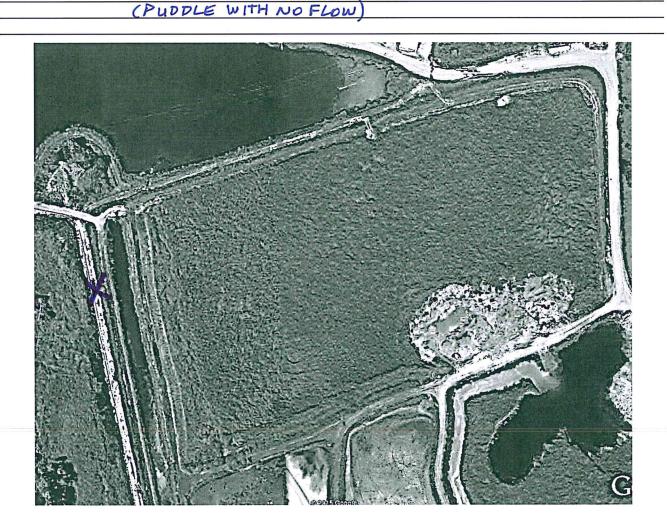
Conditions Limiting Visibility:						
□ Snow Cover		Other				
★ Vegetation		None				
Observations:						
□ Erosion / Gullies		Sudden drop in impoundment level				
□ Cracking / Sloughing		Actual or potential structural weakness				
✓ Seeps / Damp Areas		Improper operation of overtopping contro				
□ Signs of Creep		Visible release				
□ Failed/eroded vegetation >100sq ft.		No observed problems				
Describe findings. Identify locations on attached map. Attach additional pages if necessary.						
V = SEEP I OCATIONI

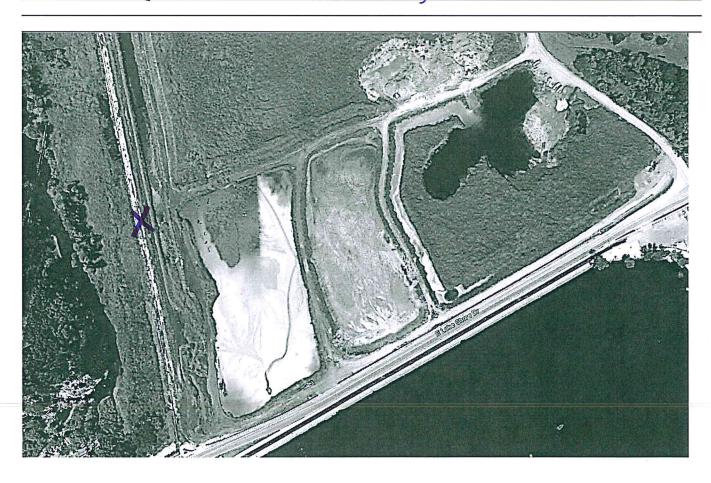
X = SEEP LOCATION

(SMAIL PUDDLE WITH NO FLOW
