City Water, Light and Power
Coal Combustion Residuals Units
40 CFR 257 and 35 IAC 845
Weekly Inspection Form

Date 11/1/23 Time 1:35

Inspector(s) / Position: Schy Willmore

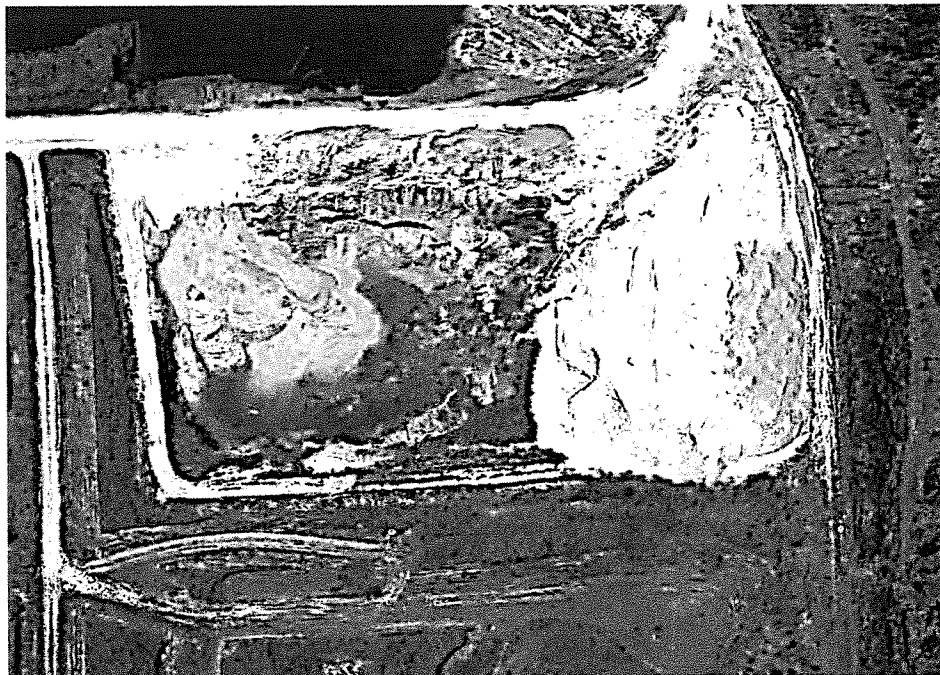
Berms – Landfill Unit 2:

- ☐ Snow Cover
☒ Vegetation

- ☐ Sudden drop in impoundment level
☐ Actual or potential structural weakness
☐ Improper operation of overtopping control
☐ Visible release
☒ No observed problems

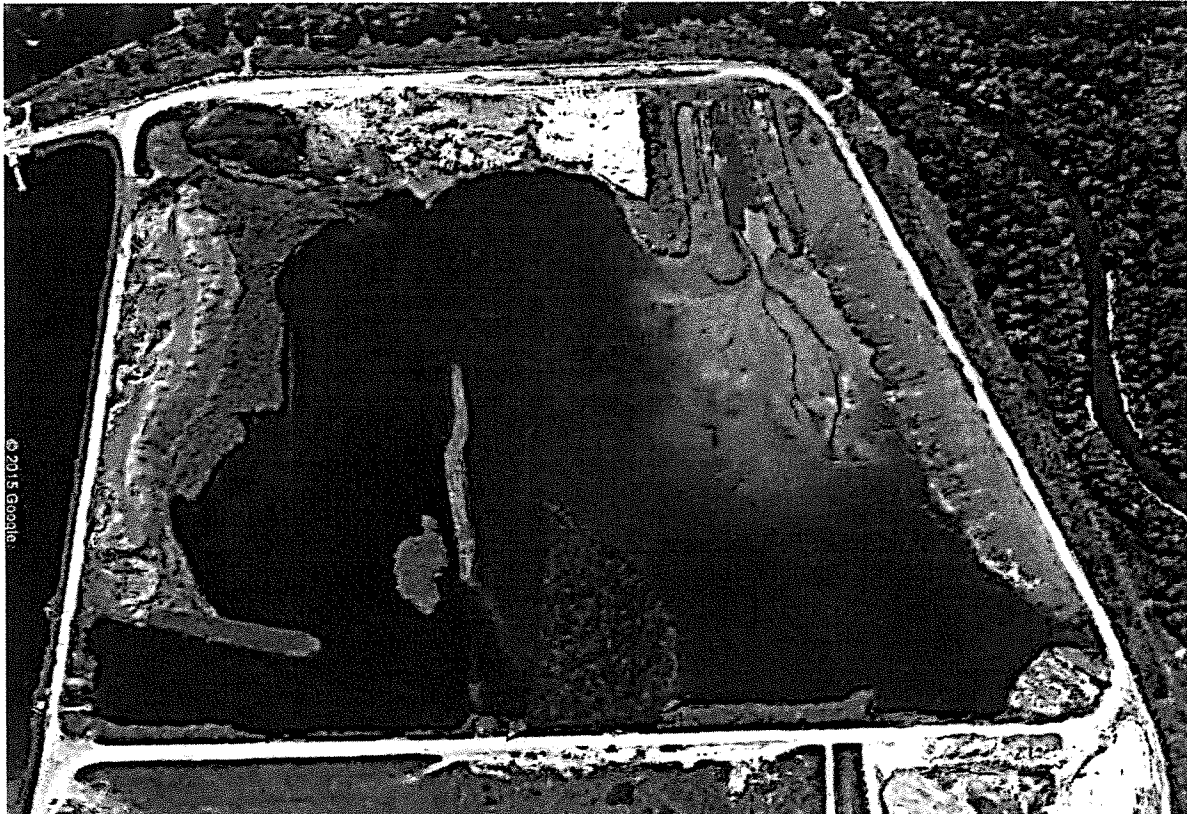
Berms – Dallman Ash Pond

☒ Vegetation

☒ No observed problems

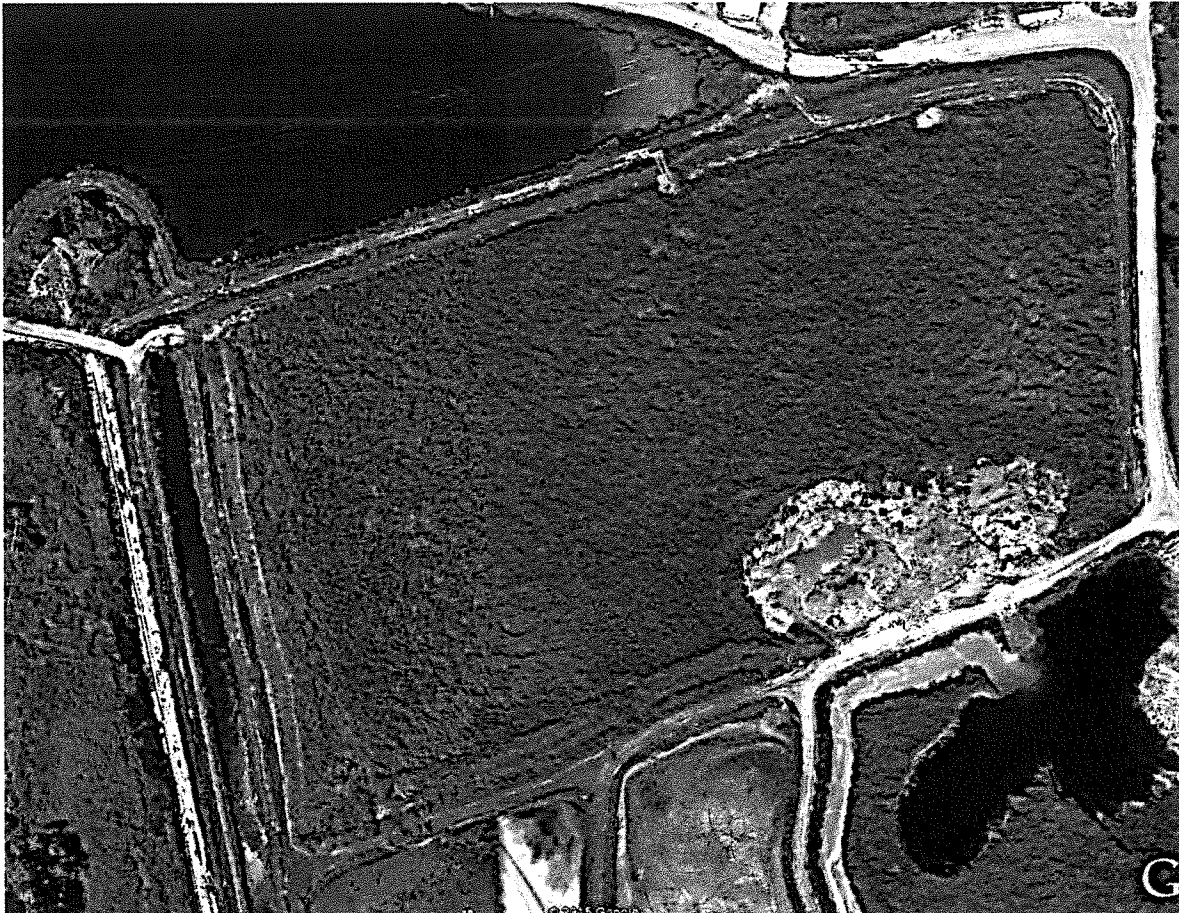
Berms – Lakeside Ash Pond

☒ Vegetation

☒ No observed problems

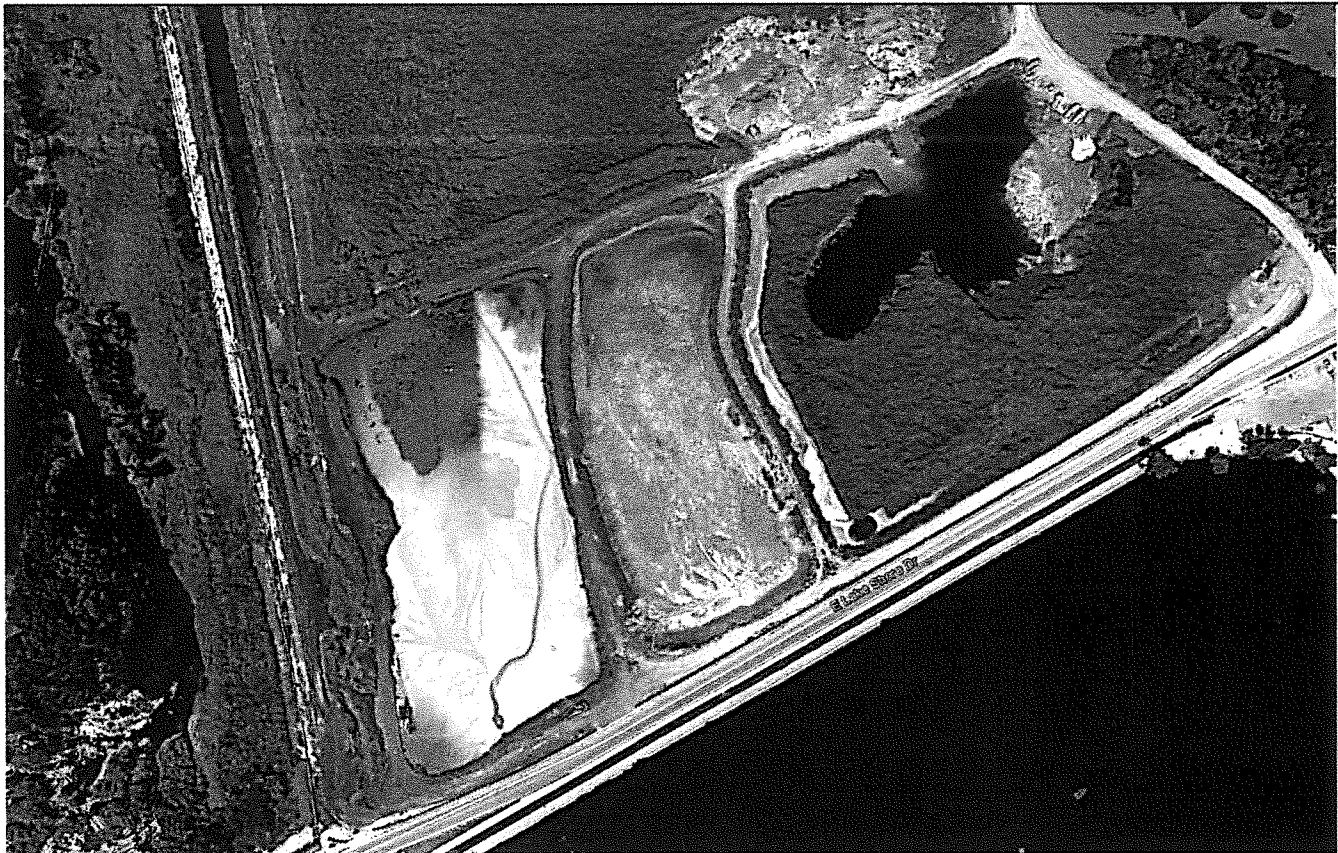
Berms – Lime Softening Ponds

☒ Vegetation

☒ No observed problems
