City Water, Light and Power
Coal Combustion Residuals Units
40 CFR 257 and 35 IAC 845
Weekly Inspection Form

Date 11-8-2023 Time 9:00 AM

Inspector(s) / Position: JIM KETCHUM

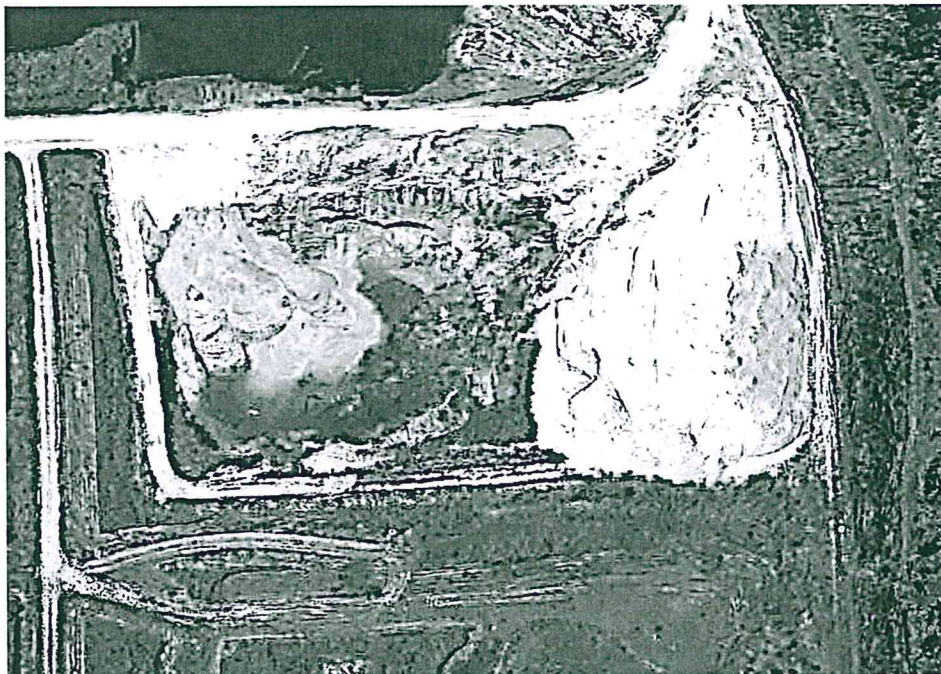
Berms – Landfill Unit 2:

| <input type="checkbox"/> Failed/eroded vegetation >100sq ft. | <input checked="" type="checkbox"/> No observed problems |

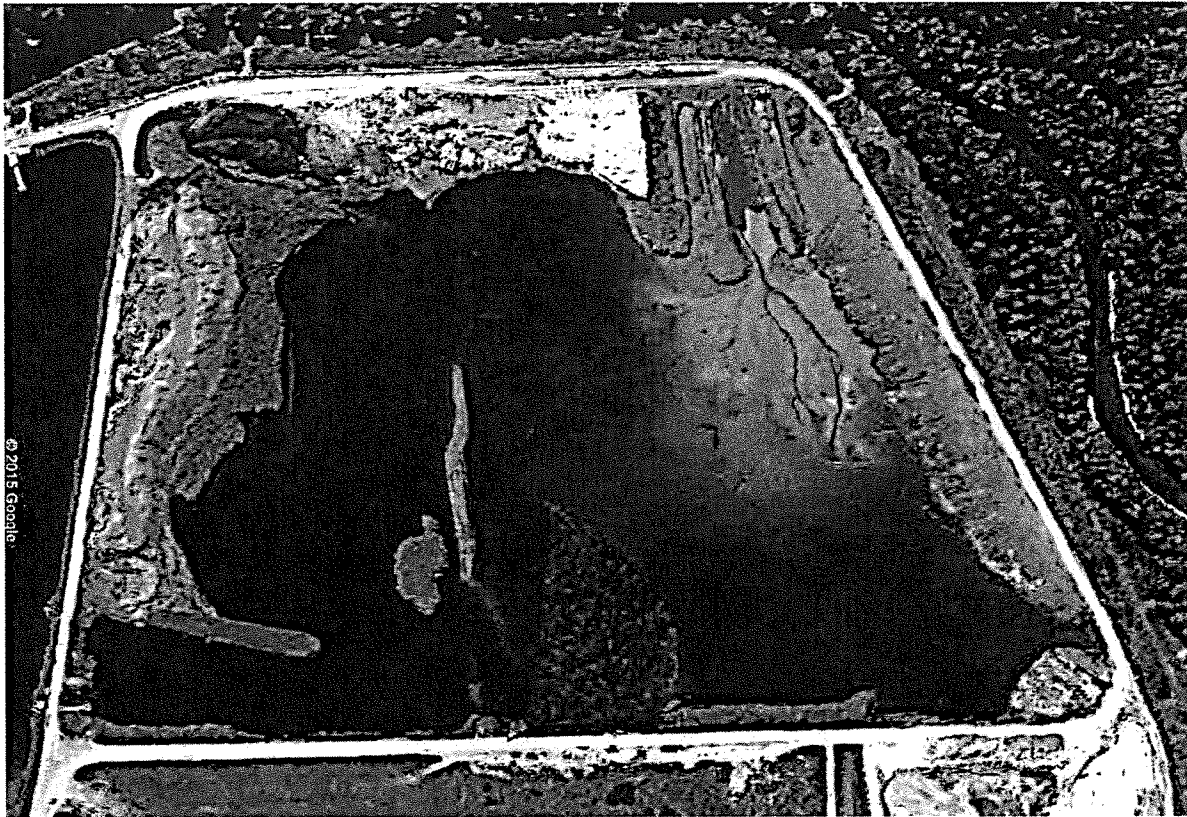
Berms – Dallman Ash Pond

☒ No observed problems

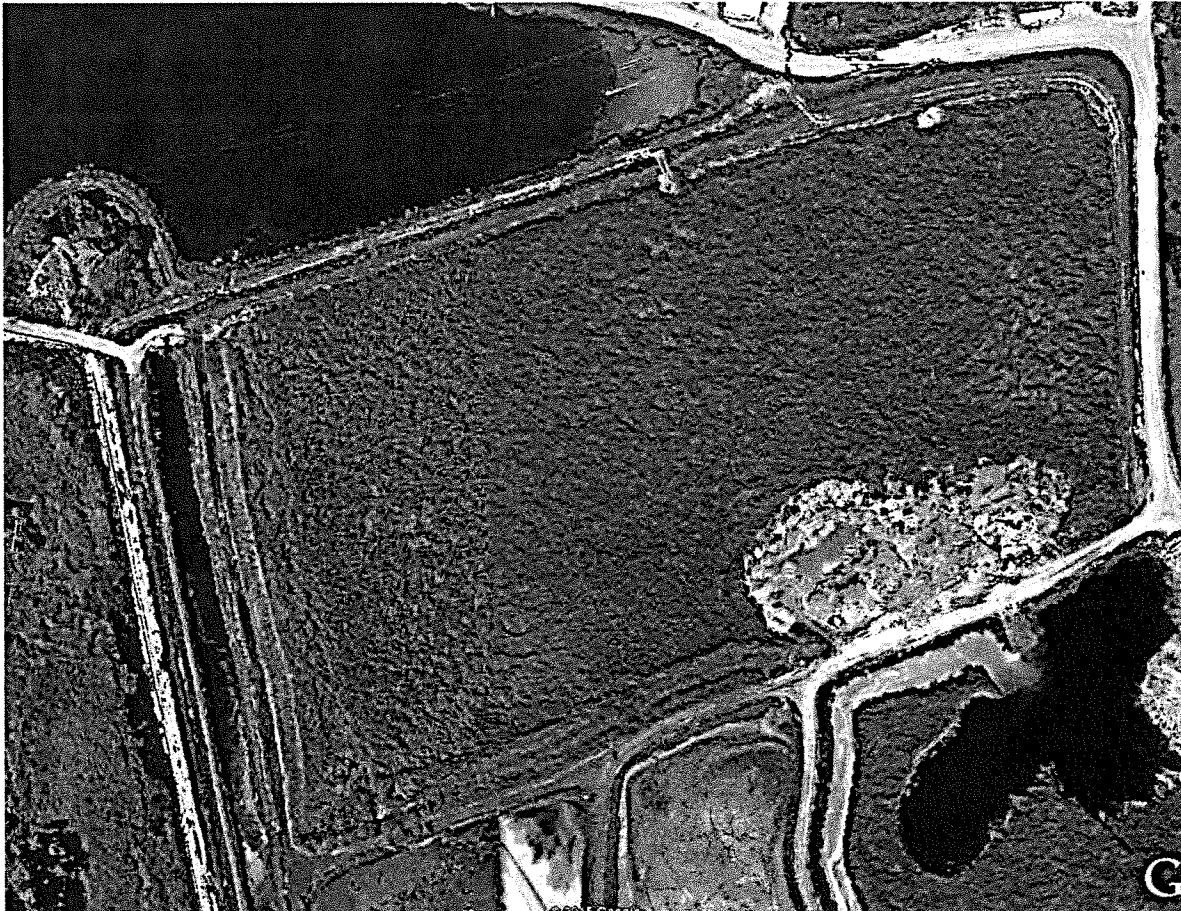
Berms – Lakeside Ash Pond

- ☐ Sudden drop in impoundment level
☐ Actual or potential structural weakness
☐ Improper operation of overtopping control
☐ Visible release
☒ No observed problems

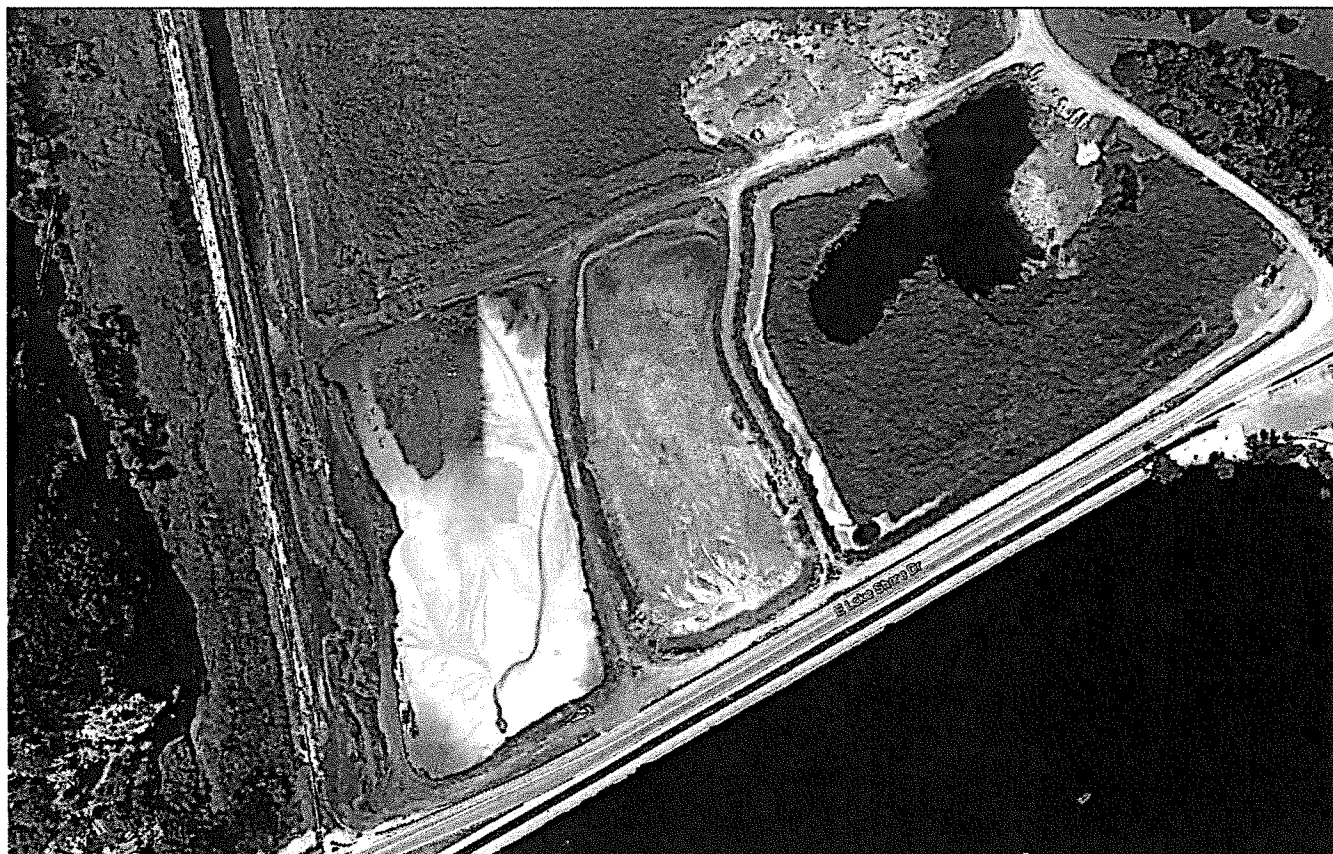
Berms – Lime Softening Ponds

☒ No observed problems
