City Water, Light and Power
Coal Combustion Residuals Units
40 CFR 257 and 35 IAC 845
Weekly Inspection Form

Date: 9-4-24 Time: 9:00 Inspector(s) / Position: Staley

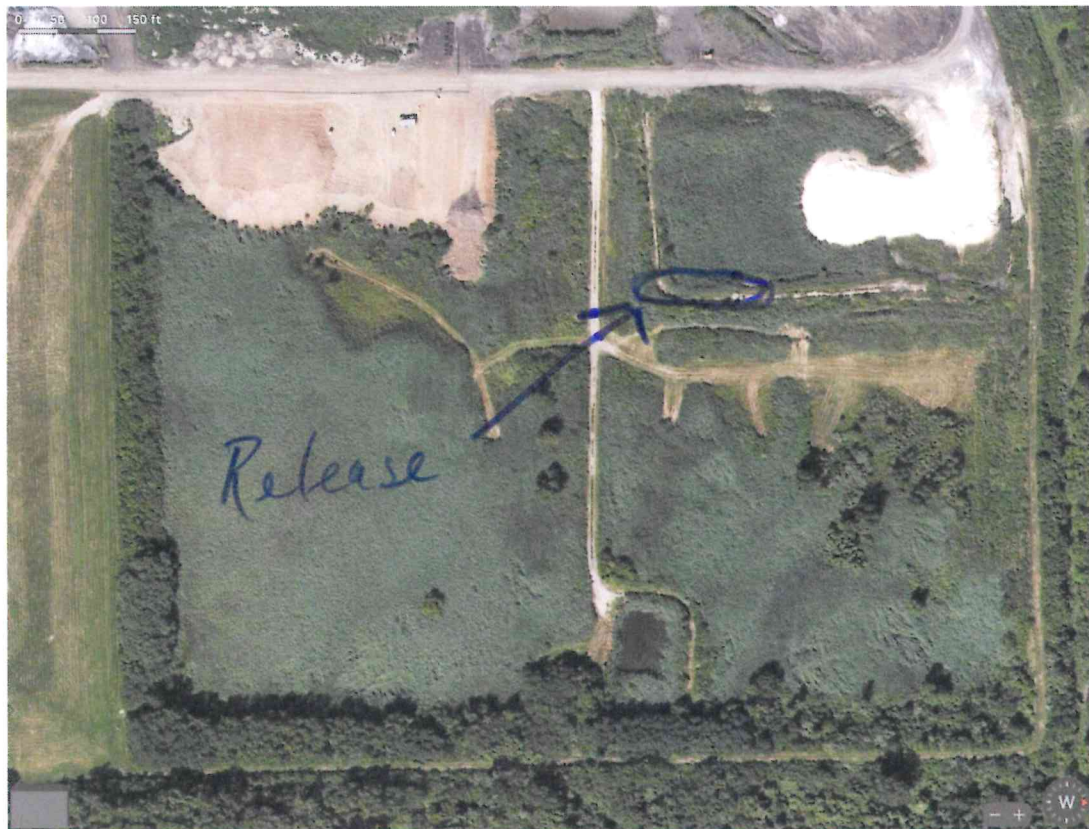
Berms – Landfill Unit 2:

Visible release. See notes on page 6.
Vegetation obscured release area to East

On Saturday August 31, calcium carbonate, a non-CCR material generated from the water purification process, was observed to have washed over the Unit 2 landfill perimeter berm after a heavy rain the evening before. The calcium carbonate (lime sludge) is permitted Illinois EPA to be stored and dewatered within the landfill before reclamation as a beneficial reuse product. The lime sludge was being stored within a temporary bermed area within the constructed berm of the landfill. The heavy rain washed some of the material beyond the temporary bermed area within the constructed berm and deposited it in the ditch within the constructed berm that contains the landfill leachate collection sump. The material appears to have entered the ditch faster than the sump could remove it and the lime sludge overtopped the south east portion of the constructed berm.

The entirety of the berm was inspected on August 31 and no actual or potential structural defects were observed as a result of the precipitation event.

At no time did leachate or lime sludge material enter waters of the State or exit the landfill boundaries nor did the event cause actual or potential structural weakness of the landfill berm.

The material was entirely contained within the facility boundary. Material retained within the ditch of the constructed berm was pumped to the Clarification Pond for treatment and eventual discharge through Outfall 004 in accordance with NPDES permit conditions. Excess water from the material was captured in the evaporation ponds and pumped to the Clarification Pond for treatment and eventual discharge through Outfall 004 in accordance with NPDES permit conditions. Solids from the lime sludge were being consolidated using heavy equipment at the time of inspection and will be hauled back into the landfill at the time of the inspection.

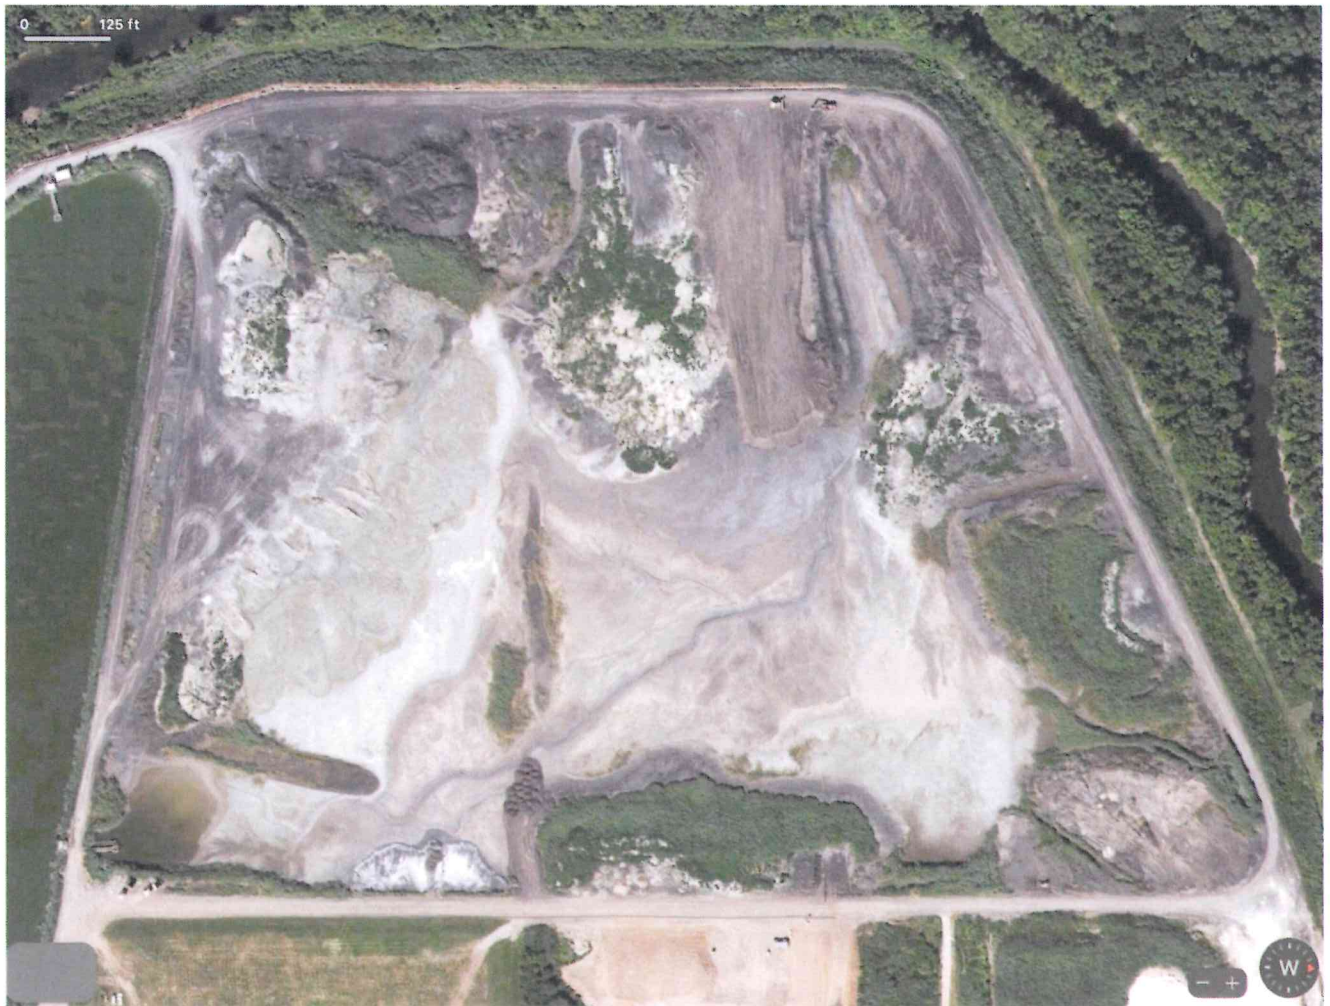
Berms – Dallman Ash Pond

| <input type="checkbox"/> Failed/eroded vegetation >100sq ft. | <input checked="" type="checkbox"/> No observed problems |

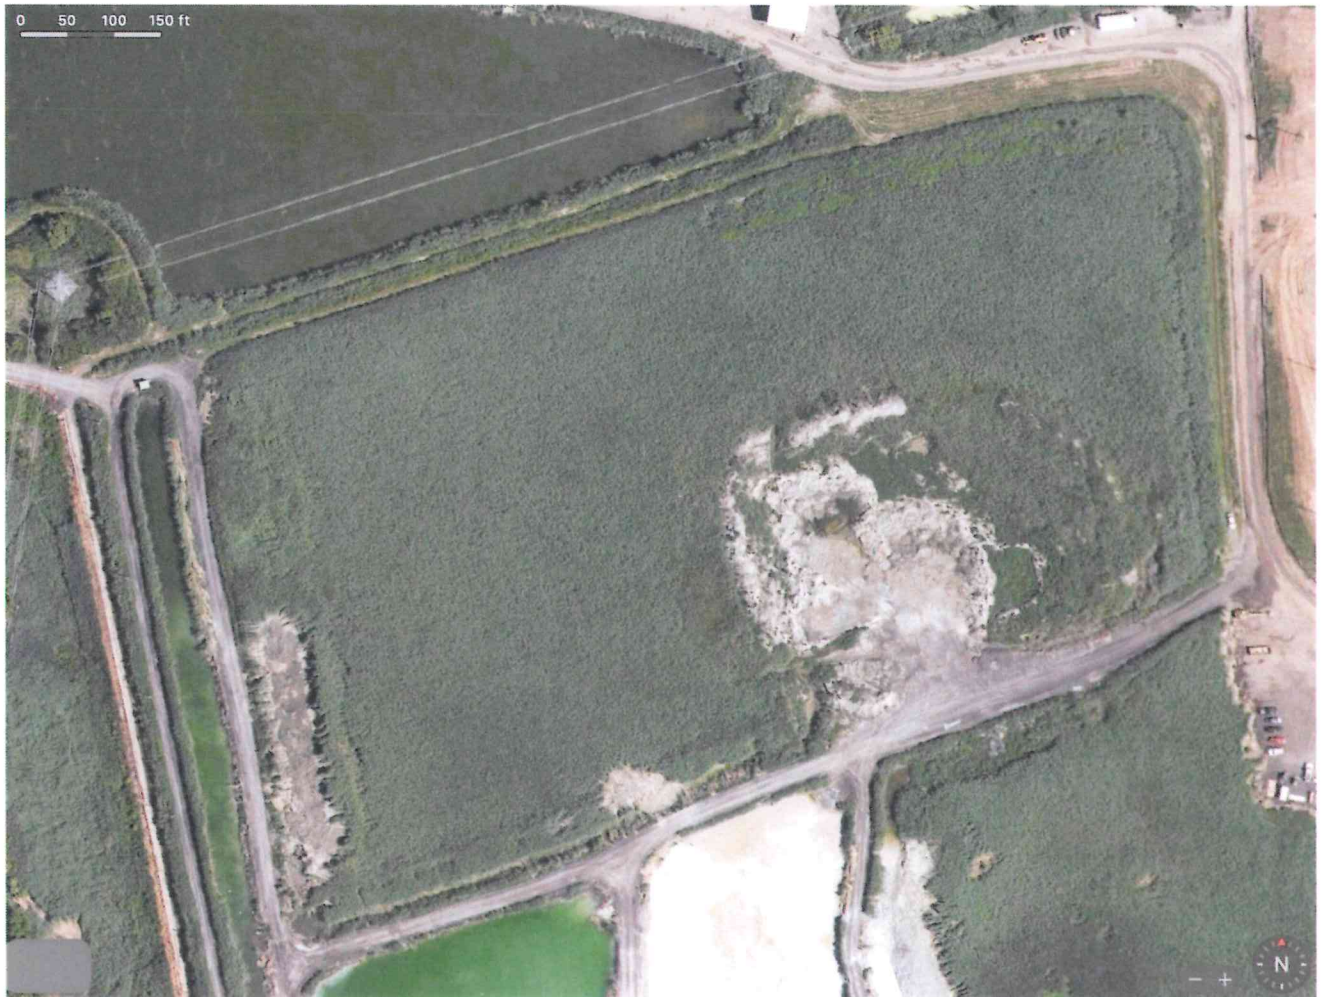
Berms – Lakeside Ash Pond

- ☐ Sudden drop in impoundment level
- ☐ Actual or potential structural weakness
- ☐ Improper operation of overtopping control
- ☐ Visible release
- ☒ No observed problems

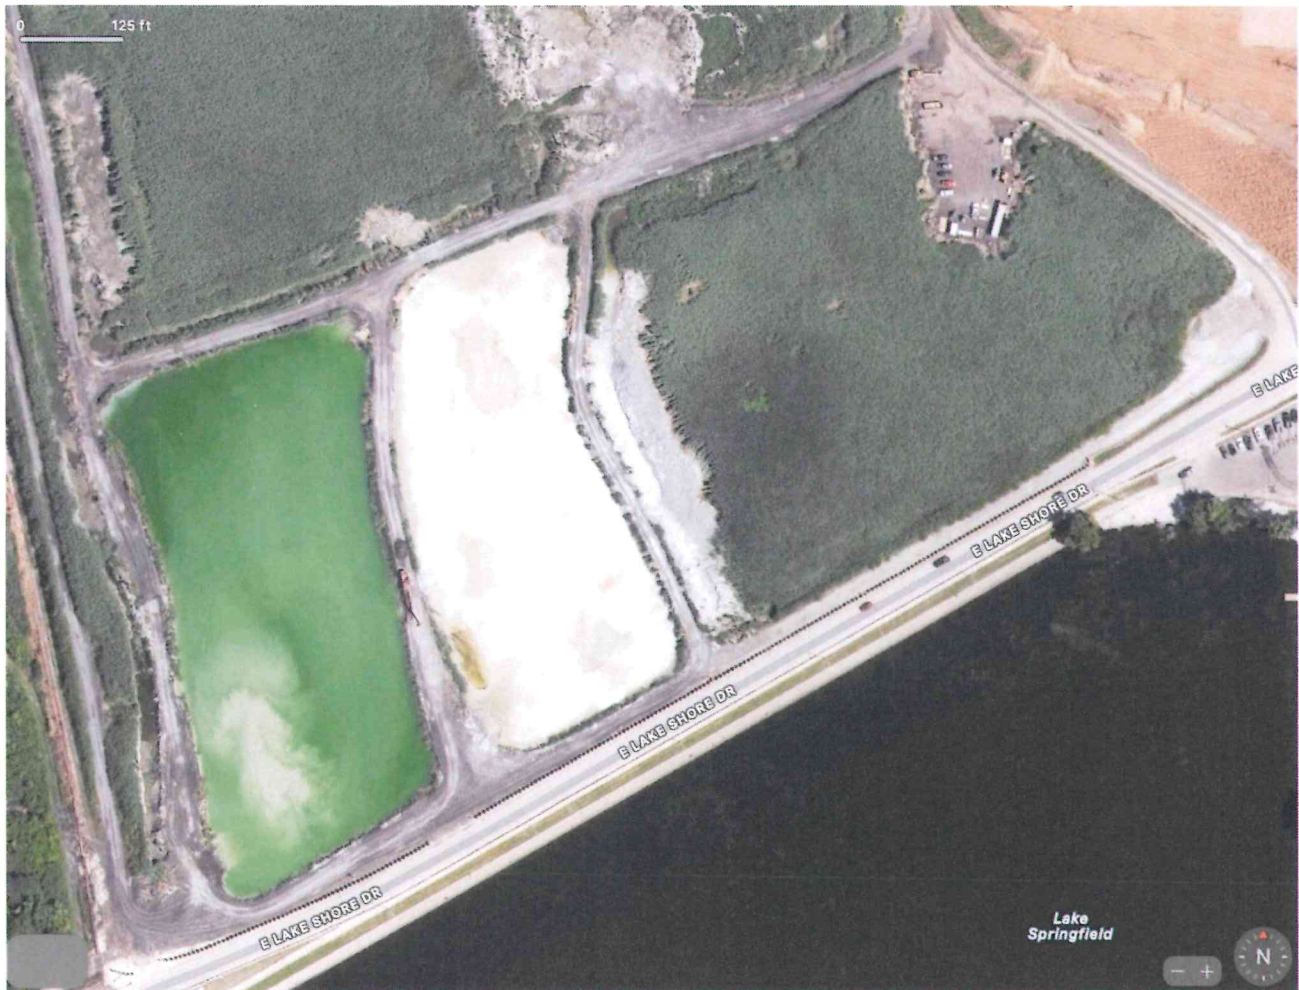
Berms – Lime Softening Ponds

- ☐ Sudden drop in impoundment level
- ☐ Actual or potential structural weakness
- ☐ Improper operation of overtopping control
- ☐ Visible release
- ☒ No observed problems
