City Water, Light and Power
Coal Combustion Residuals Units
40 CFR 257 and 35 IAC 845
Weekly Inspection Form

Date: 11-6-24 Time: 11:40 Inspector(s) / Position: Staley

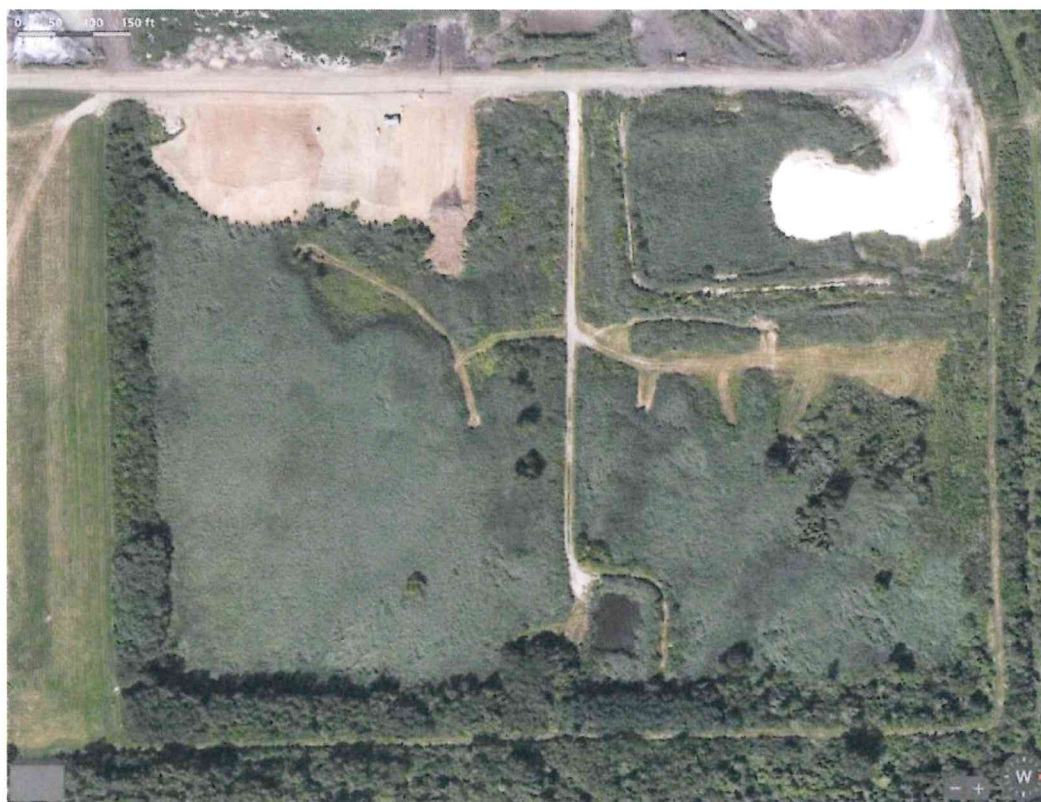
Berms – Landfill Unit 2:

☒ No observed problems

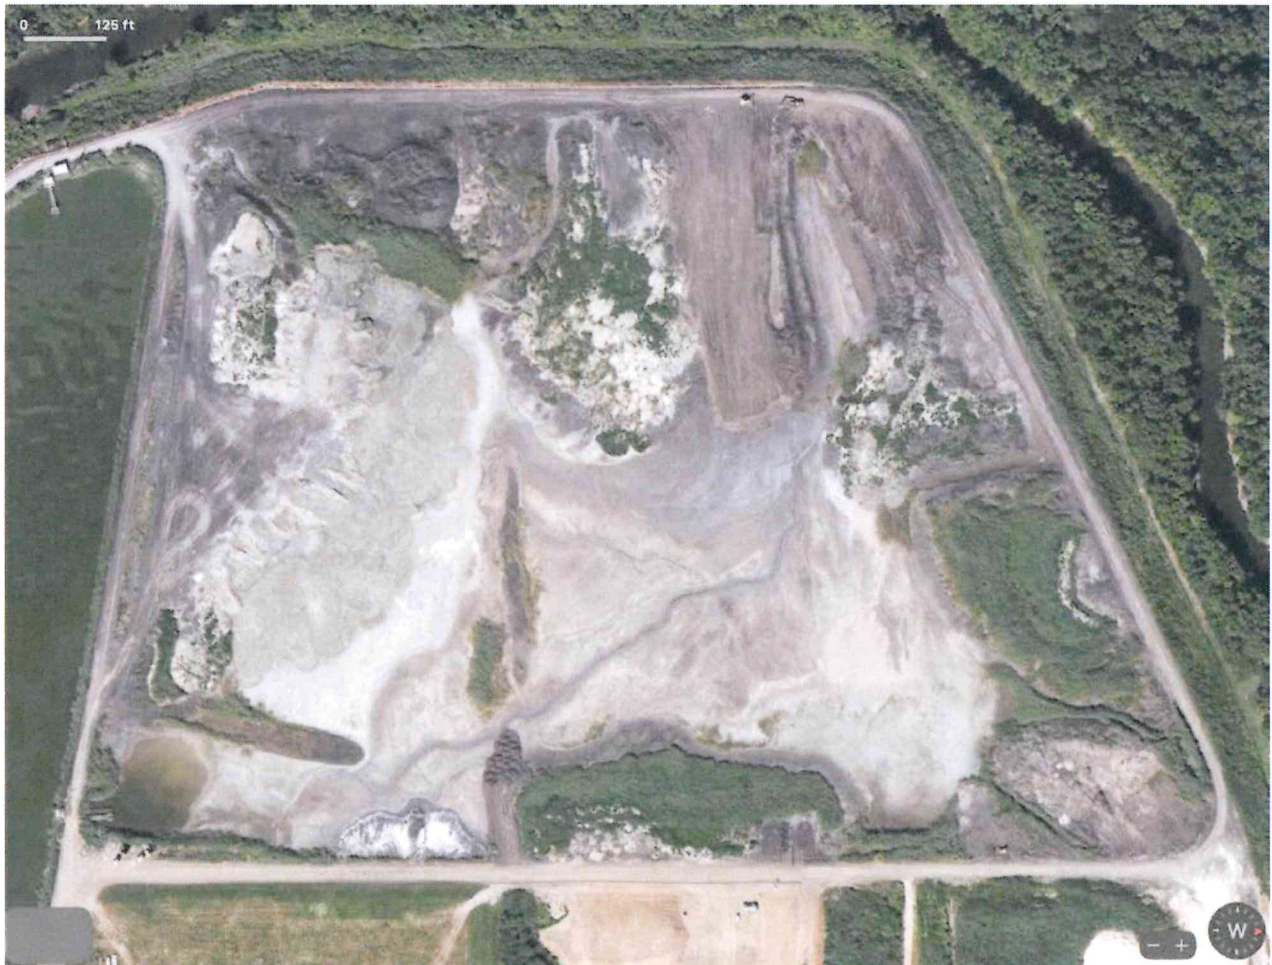
Berms – Dallman Ash Pond

- ☐ Sudden drop in impoundment level
- ☐ Actual or potential structural weakness
- ☐ Improper operation of overtopping control
- ☐ Visible release
- ☒ No observed problems

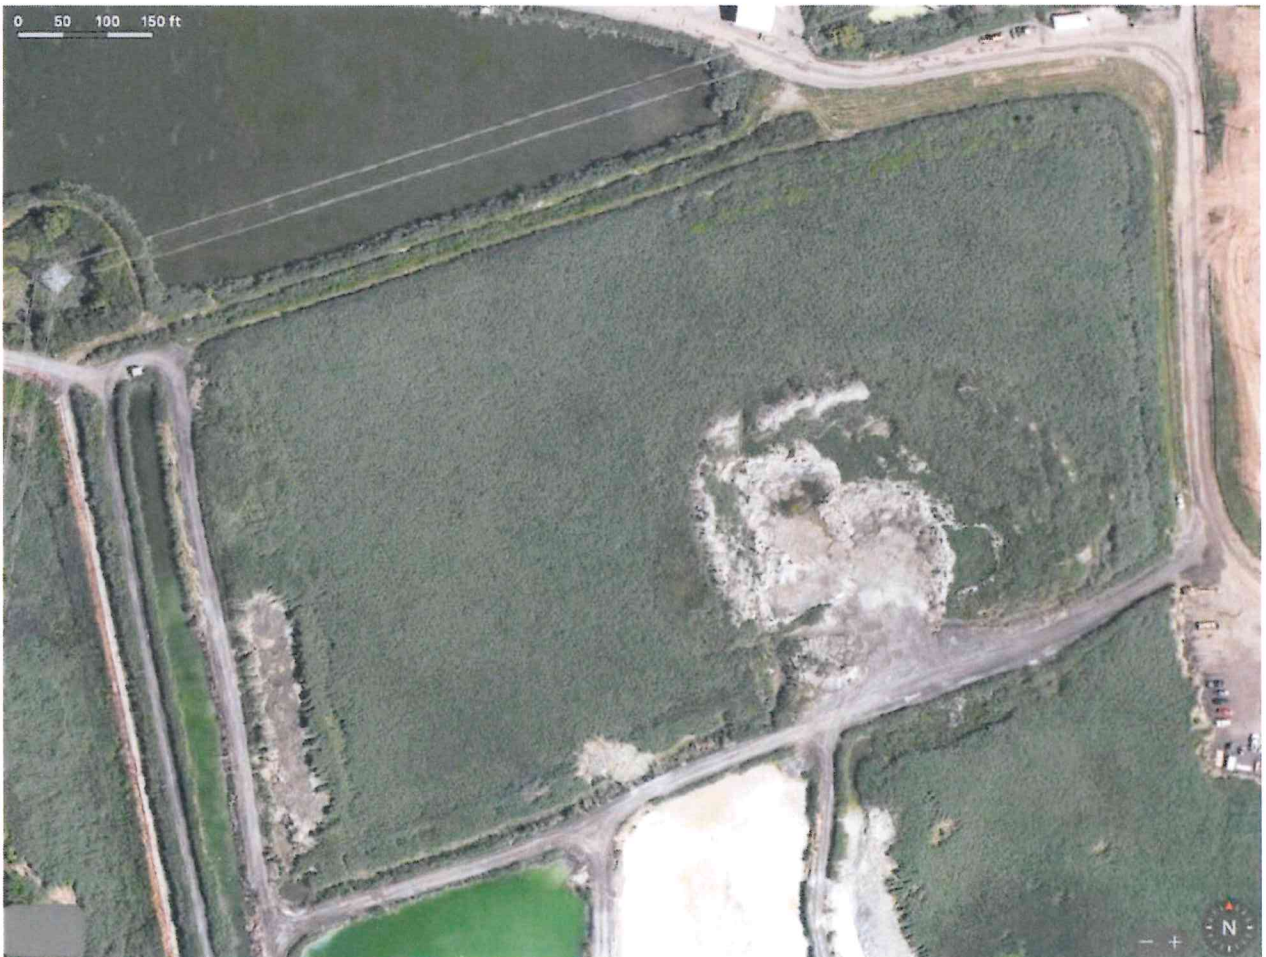
Berms – Lakeside Ash Pond

- ☐ Sudden drop in impoundment level
- ☐ Actual or potential structural weakness
- ☐ Improper operation of overtopping control
- ☐ Visible release
- ☒ No observed problems

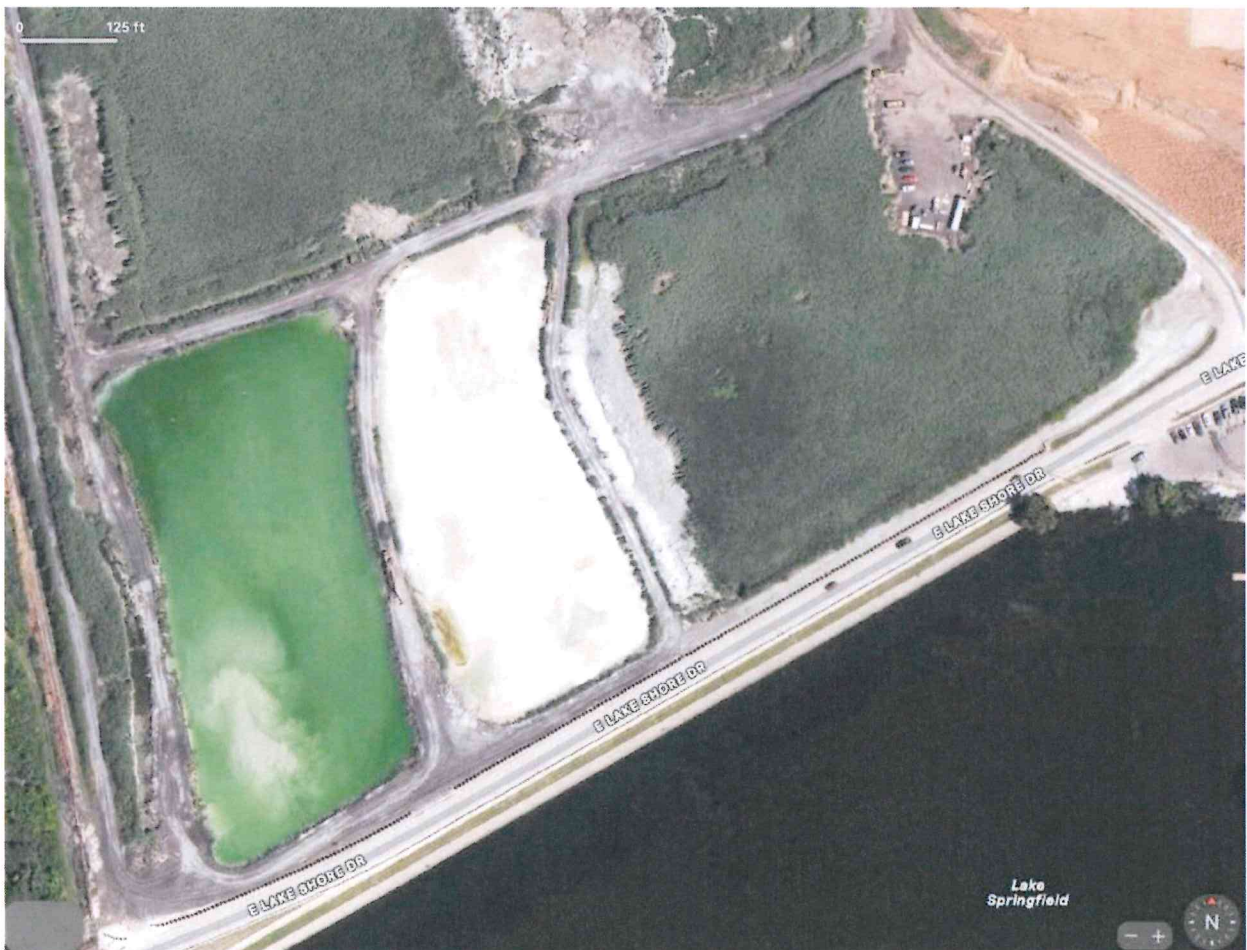
Berms – Lime Softening Ponds

- ☐ Sudden drop in impoundment level
- ☐ Actual or potential structural weakness
- ☐ Improper operation of overtopping control
- ☐ Visible release
- ☒ No observed problems
