**City Water, Light and Power**  
**Coal Combustion Residuals Units**  
**40 CFR 257 and 35 IAC 845**  
**Weekly Inspection Form**

Date: 1/19/29 Time: 1:30 Inspector(s) / Position: Schly Willmore

**Berms – Landfill Unit 2:**

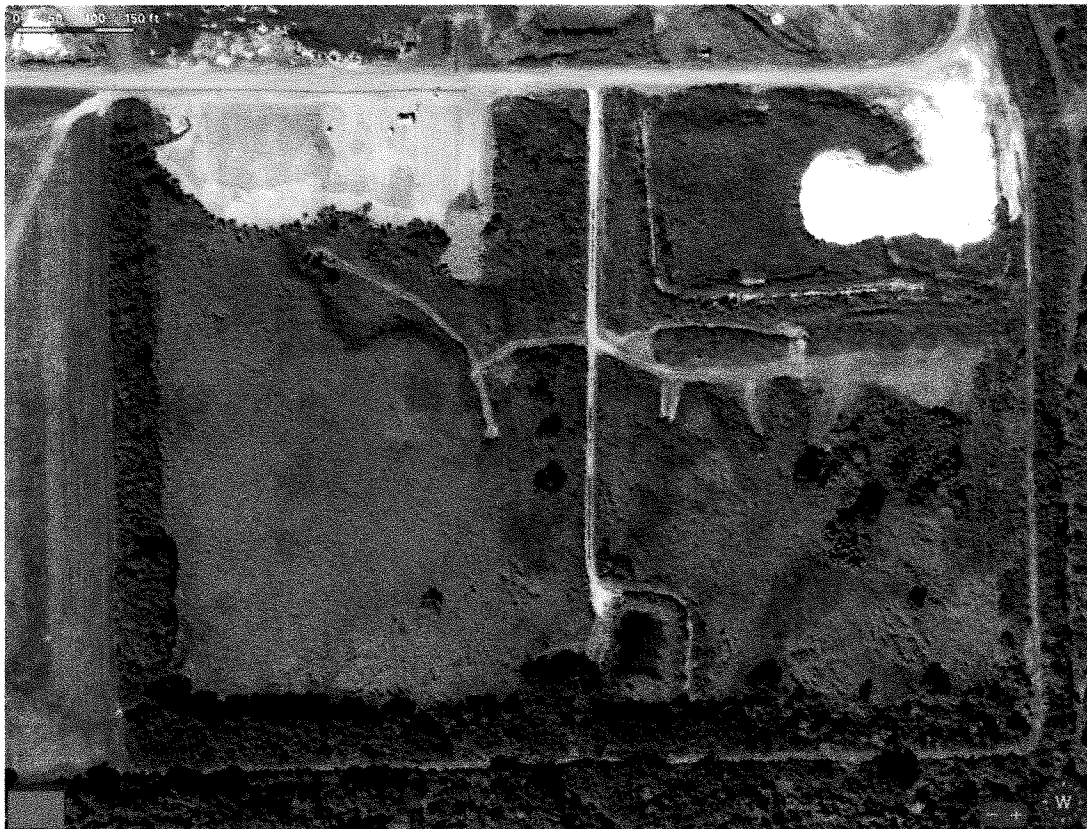
- ☒ Snow Cover  
☐ Vegetation

- ☐ Sudden drop in impoundment level  
☐ Actual or potential structural weakness  
☐ Improper operation of overtopping control  
☐ Visible release  
☒ No observed problems

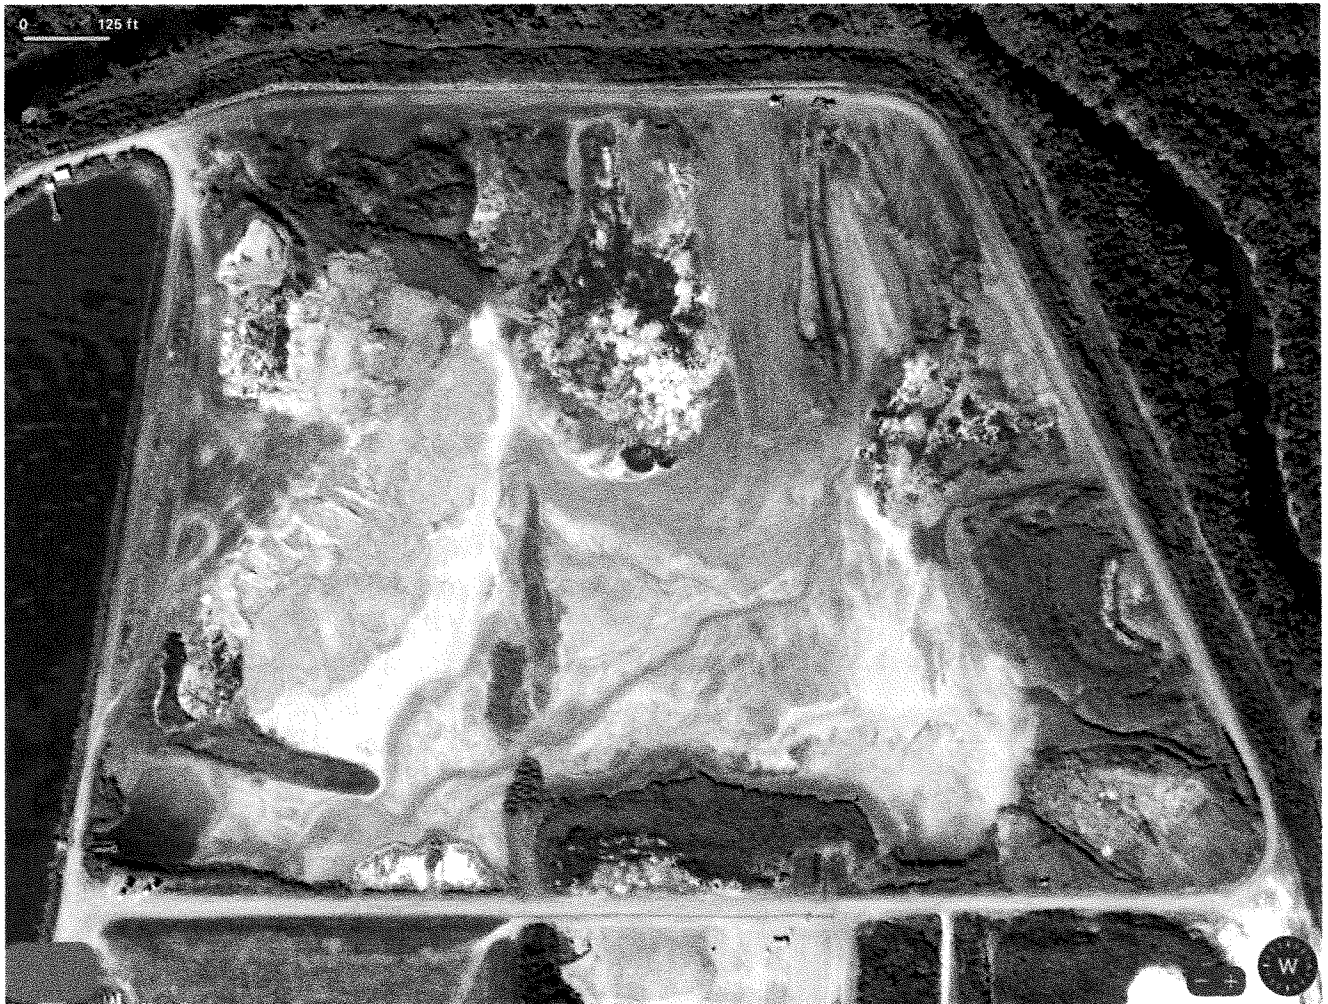
**Berms – Dallman Ash Pond**

- ☒ Snow Cover  
☐ Vegetation

| <input type="checkbox"/> Failed/eroded vegetation >100sq ft. | <input checked="" type="checkbox"/> No observed problems |

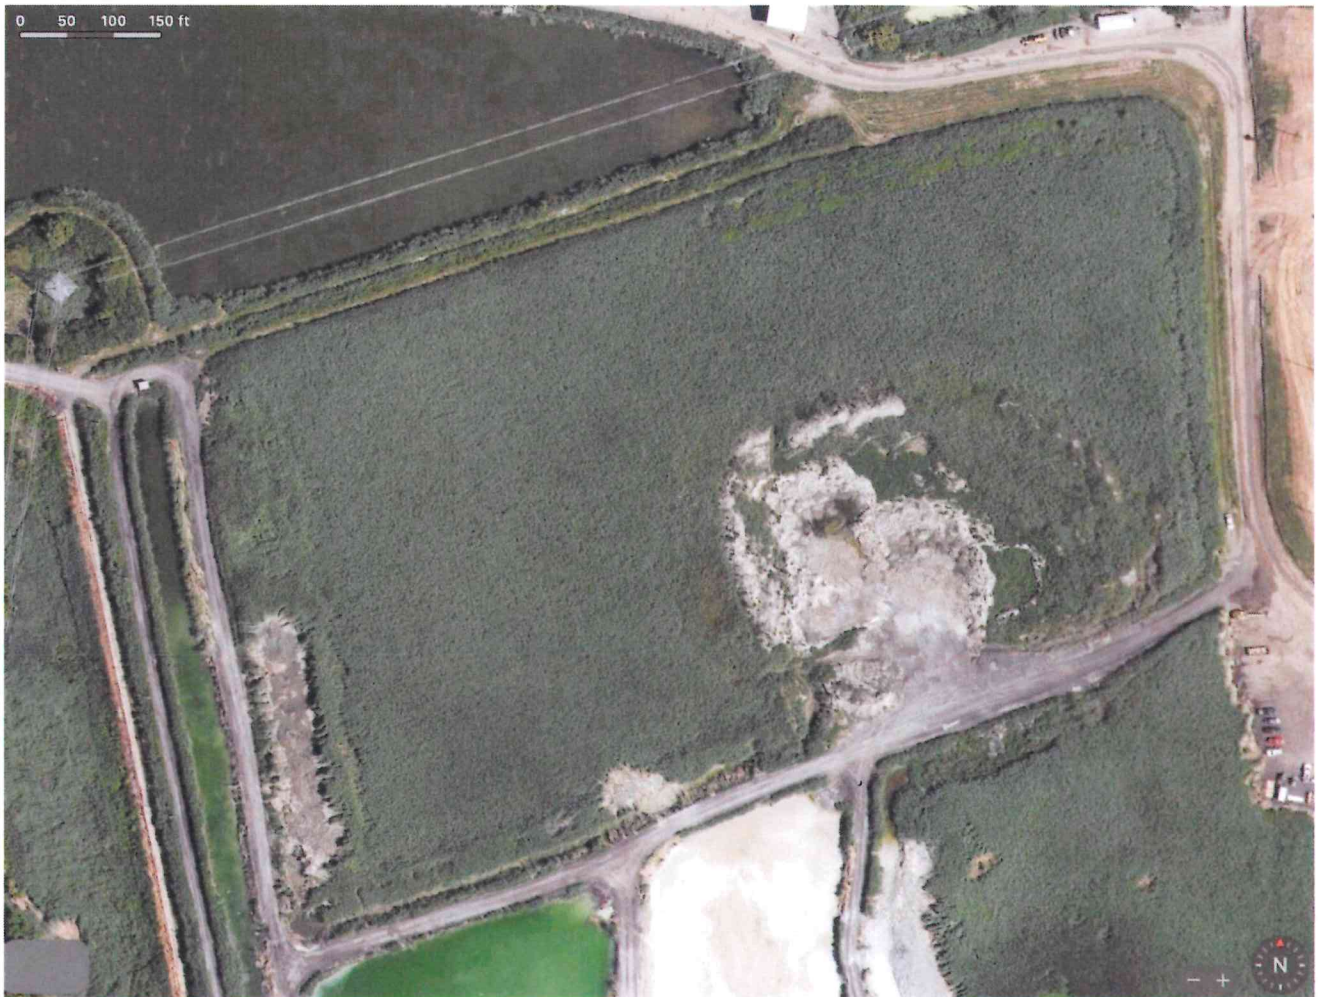
**Berms – Lakeside Ash Pond**

- ☒ Snow Cover  
☐ Vegetation

| <input type="checkbox"/> Failed/eroded vegetation >100sq ft. | <input checked="" type="checkbox"/> No observed problems |

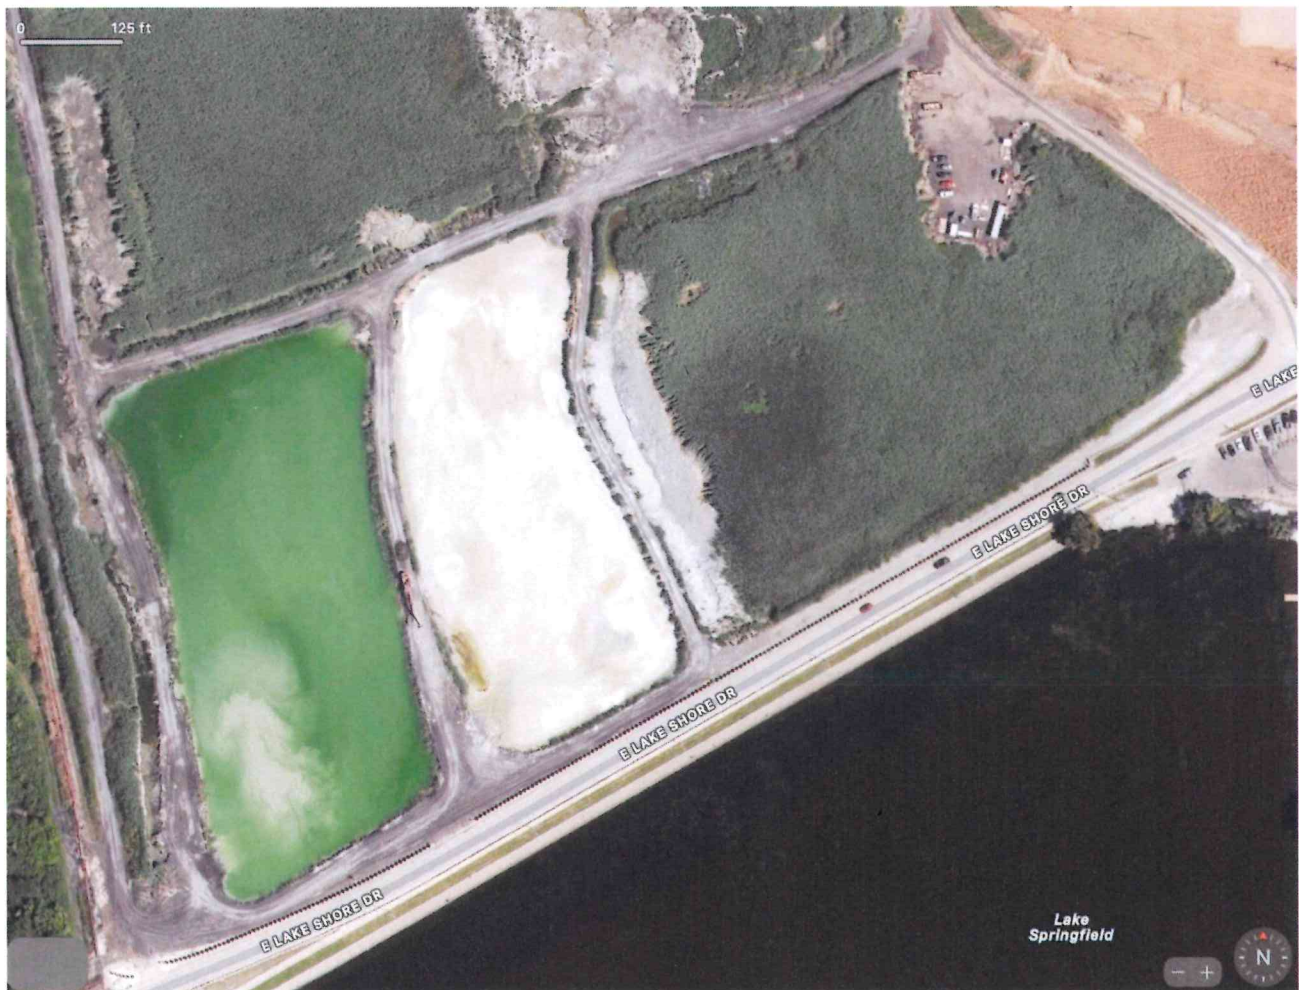
**Berms – Lime Softening Ponds**

- ☒ Snow Cover  
☐ Vegetation

- ☐ Sudden drop in impoundment level  
☐ Actual or potential structural weakness  
☐ Improper operation of overtopping control  
☐ Visible release  
☒ No observed problems
