35 IAC 845 Weekly Inspection Form

Berms - Lakeside Ash Pond

Berms - Lime Softening Ponds

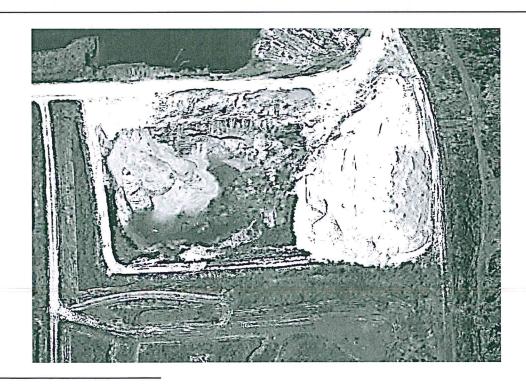
Date	7-26-2023	Time	9:00 AM				
Inspector(s) / Position: TIM KETCHUM							
Site Conditions: LIGHT Sky: <u>CLOUDS</u> Ground Moisture: DRY Temperature: 83°F Precipitation: NONE							
Berms – Landfill Unit 2:							
Conditions Limiting Visibility:							
	Snow Cover		Other				
×	Vegetation		None				
Observations:							
	Erosion / Gullies		Sudden drop in impoundment level				
	Cracking / Sloughing		Actual or potential structural weakness				
	Seeps / Damp Areas		Improper operation of overtopping control				
	Signs of Creep		Visible release				
	Failed/eroded vegetation >100sq ft.	×	No observed problems				
Describe findings. Identify locations on attached map. Attach additional pages if necessary.

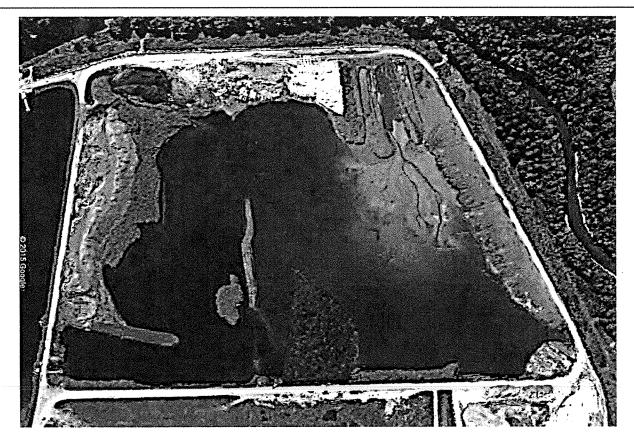
Berms	s – Dallman Ash Pond					
Condit	ions Limiting Visibility:					
	Snow Cover		Other			
×	Vegetation		None			
Observ	vations:					
	Erosion / Gullies		Sudden drop in impoundment level			
	Cracking / Sloughing		Actual or potential structural weakness			
	Seeps / Damp Areas		Improper operation of overtopping control			
	Signs of Creep		Visible release			
	Failed/eroded vegetation >100sq ft.	X	No observed problems			
Describe findings. Identify locations on attached map. Attach additional pages if necessary.
